Survival Factors

Airbag Safety Study

October 8, 2009

Location: Boyd, TX
Aircraft Type: Cessna 172 SP
Accident Date: July 14, 2009
Accident Time: 1750 CDT
Accident Number: N2446F, CEN09LA442
Airbag Equipped: Yes

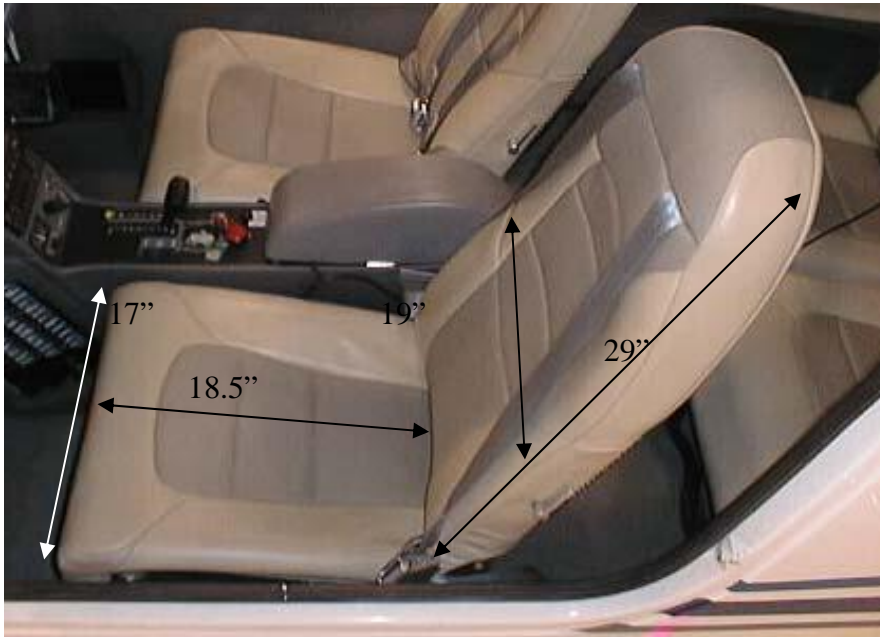
Figure 8: Relative dimensions of the Cessna seats (photograph is of exemplar Cirrus seats).

The front seats were measured and their dimensions are documented on an exemplar photo in figure 8. The left seat (figure 9) was occupied by the pilot. The seat was intact. The seat position locking pins were fully engaged in second hole from front. Damage was observed to right front wheel assembly from impact with seat rail. The seat pan was displaced approximately 0.25" at the front bend line and 1.40" at the aft bend line (compared to the undamaged right seat measurements)

The right seat was not occupied; however it was inspected for comparison to left seat. The seat position locking pins were fully engaged in the eighth hole from the front.

Both sets of seat rails were intact and attached to the floorboard. The right seat's seat rail appeared unremarkable. The left seat's left inboard rail was bent upward at the forward end approximately 1" from the nose wheel penetration. The left seat's outboard rail appeared unremarkable.
